HA-287

Gravity Flow
3226 Harmony Church Road
Darlington, Maryland 21034

INVENTORY FORM FOR STATE HISTORIC SITES SURVEY

MD. HISTORICAL TRUST
BOX 1704
ANNAPOLIS, MD. 21404NATIONAL REGISTER OF HISTORIC PLACES
INVENTORY - NOMINATION FORM

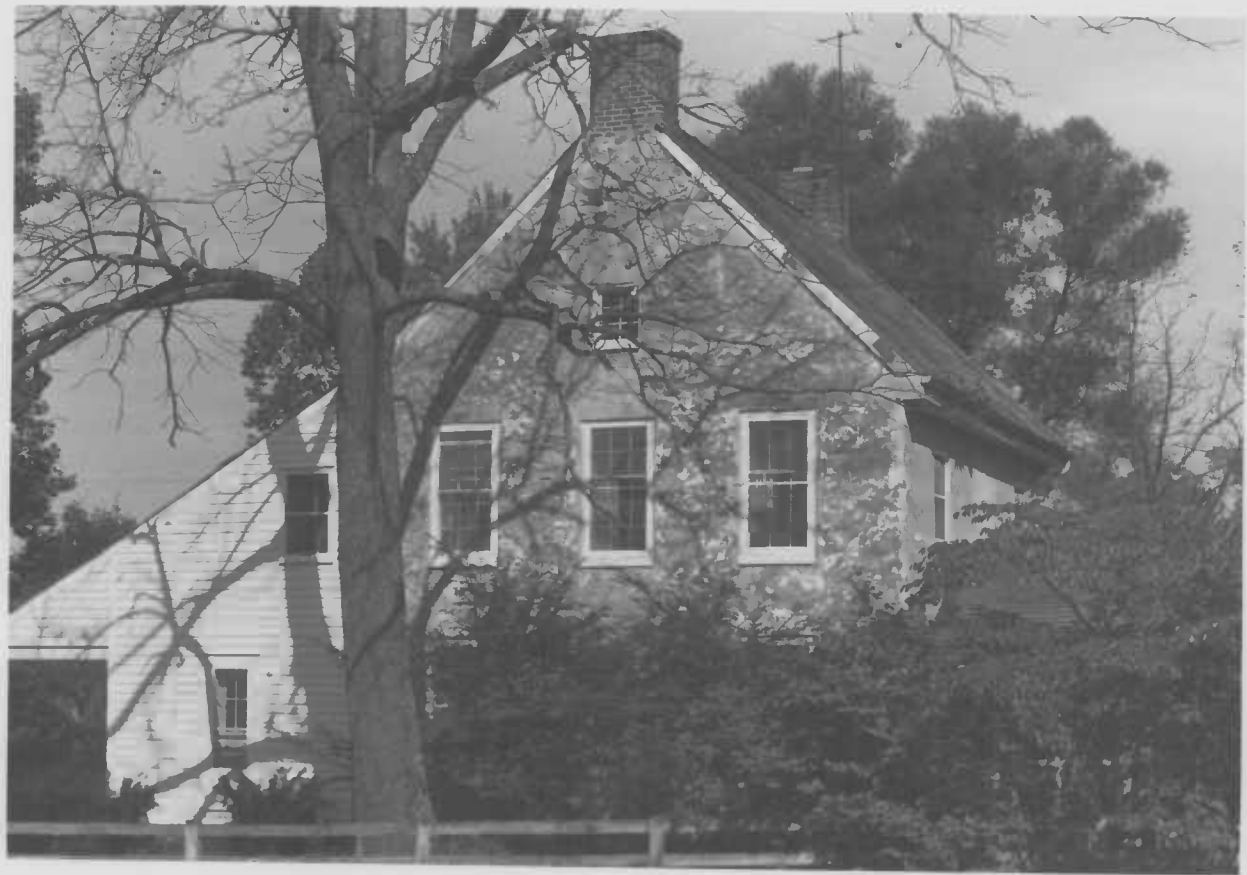
South

The two windows on the first elevation of the south are six lights over nine. Three windows on the second elevation are also six lights over nine. An usual break in the surface of the wall might indicate the possible removal of a center window on the first elevation of this facade. An attic window on this side has a six light, casement window.

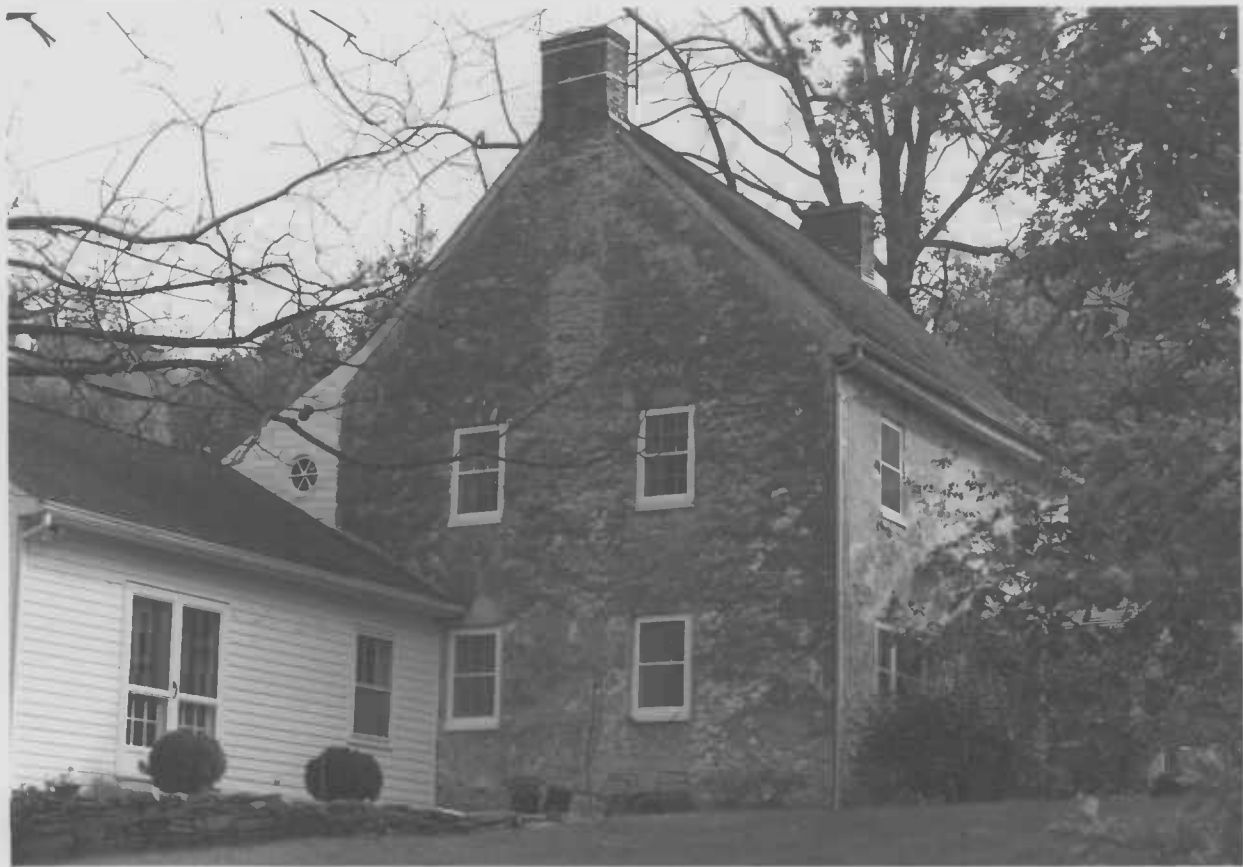
Northwest

On the north facade windows on both the first and second elevation are six lights over six. Brick flat arches are visible over the second story windows where stucco is worn. As was mentioned earlier, an attic window on this side has been closed up.

The west facade has been altered by a screened in entrance porch on the south bay. The northern bay has had a larger window - cut in - changing that window from probably nine over six sashes to a combination of windows, 2/2, 4/4, 2/2. There seems to have been another door or window in the center of this facade on both elevations at one time.
